Introduction:

A factory flaw was brought to light due to a critical incident that had occurred when an Arizona DPS State Trooper attempted to discharge his issued FN model FNS pistol in the line of duty. During the altercation, the muzzle of the trooper's firearm was pressed against the torso of a combative subject when he pulled the trigger. By design the semiautomatic pistol will not fire when the slide is out of battery. However, while using one of our reference collection FN model FNS 40 pistols to show the investigators the trooper's firearm did not malfunction, it was determined the trigger was not resetting completely (Images 1-3). When the pistol was placed on the table top, its striker could be heard releasing forward. This raised the question of whether the pistol would fire a chambered cartridge without having your finger on the trigger.

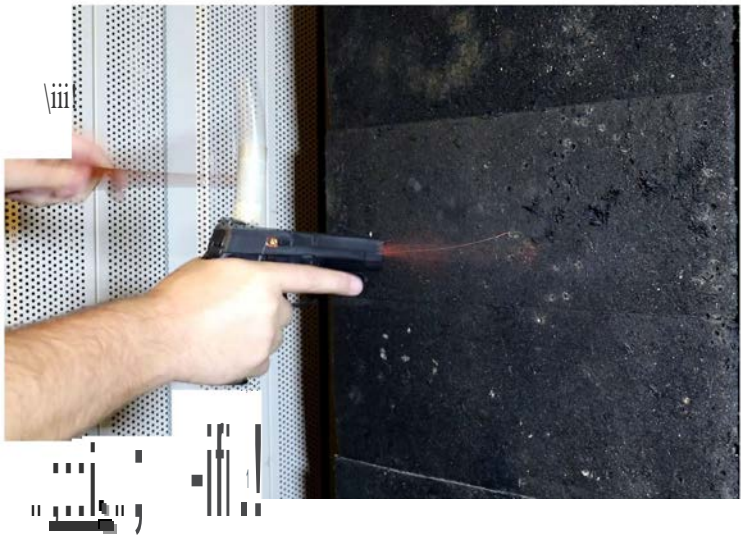
It was determined after disassembling the pistols that due to its design the striker would remain in the "cocked" position, held back by the striker block (Images 7-9). This was caused by a machined notch on the side of the striker. In this condition, with the trigger not reset, the only part retaining the striker in

this “cocked” position was the striker block. When the slide was tapped with a mallet or the firearm jarred at all it would cause the notch on the striker to bypass the striker block and fire the pistol.

Image 7: S triker block holding the faulty st riker on the first notc h

FN was contacted, and after showing video footage of both scenarios they quickly provided the installation of replacement parts to correct the defective parts in the department’s duty weapons as well as personal weapons purchased by DPS personnel. The corrective action was to replace the strikers from affected pistols to the new FN model 509 type striker. The machined notch that was present on the FNS models was no longer present on the model 509 strikers (Image 10). Similar testing was conducted using the new strikers and it was found to have corrected the problem.
